**TECHNICAL BULLETIN**

**FATIGUE RESISTANT OMNI-FLEX®**

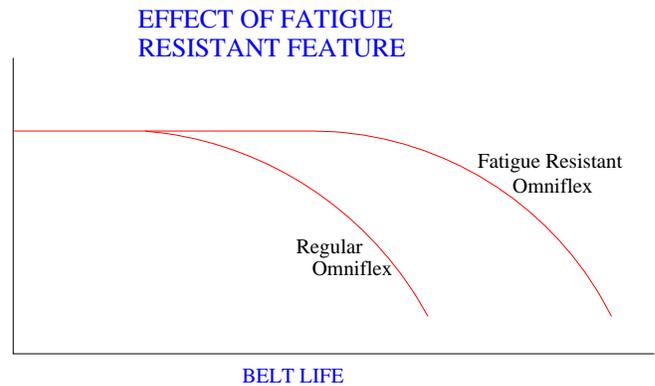
➤ **Experience has revealed that speed has an impact on belt rating.**

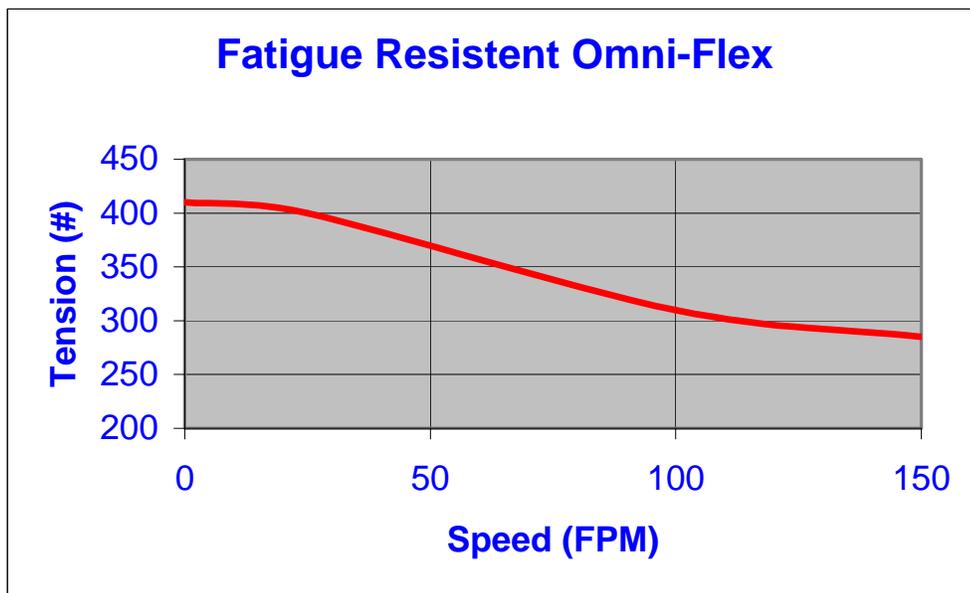
The chart below shows the ratings at various speeds. Ashworth Bros. Inc., does not recommend this belt be run at speeds greater than 150 ft/min.
